Regional Support Office for East and Southern Africa (Nairobi)

RAPPORT DE MISSION

Subject: South Sudan WASH RSO Mission (WASH in camp in Bentiu)
Auteur: Jerome BURLLOT (WASH Adviser/RSO Nairobi)
Date: Du 12 au 17 January 2015

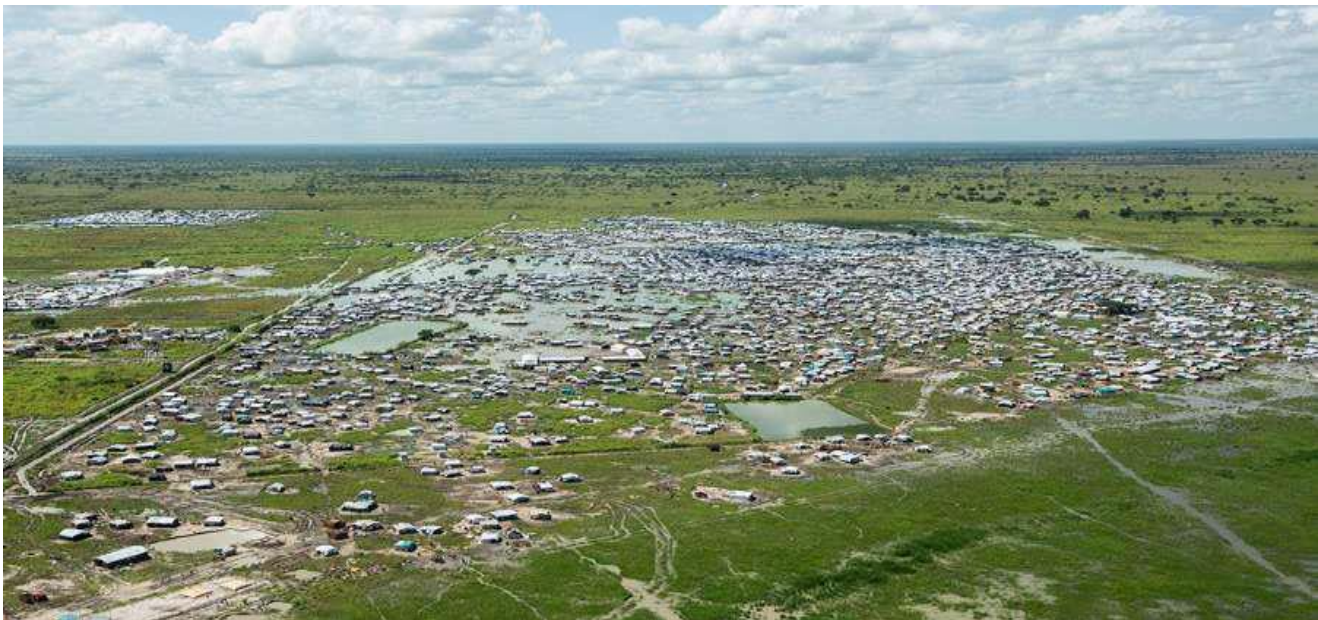
The total area of the Bentiu POC and surrounding areas surveyed in about 6 km². The area of PoC Bentiu is located in the swampy catchment area of the Rubkona River with some part of the PoC located in a seasonal river bed. At the moment, drainage work is being carried out to evacuate the water about 2.5km from Bentiu POCs to the nearest seasonal river bed as temporary measure to minimize the damage of the flood in the area. This is being done using drainage channels and plumbing of water from the POCs to these channels.

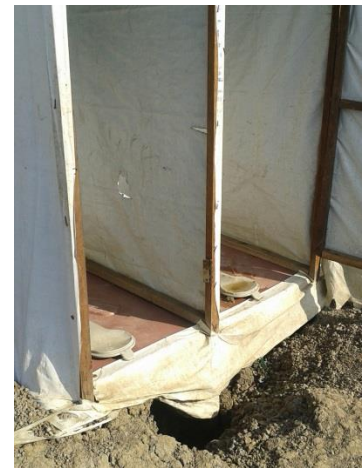
Even whether the situation have been slightly improved about open defecation (according the partners), still it is a pretty high concern. The situation seems to be worse than in most of the site visited in South Sudan, as it was highly noticeable within the dense area, but especially at the edge of the different settlement. In addition, many of the latrine blocks (most of it having 4 stances) seems to be not regularly used (level of pit filling compares to last desludging...). Numerous of the visited structures were in very bad shape with many missing part of the facilities: plastic sheeting, doors...

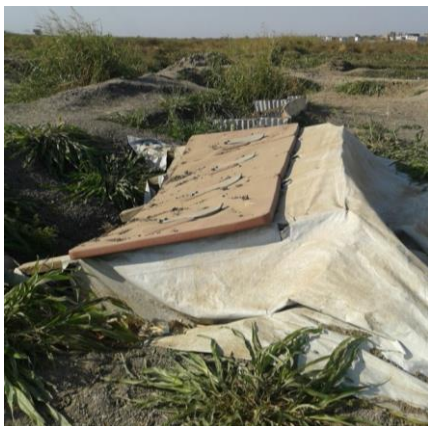
During our visit we notice, especially on part of POC 4, POC 5 and 6 (normally CARE was in charge) **numerous abandoned unfinished or damaged latrine, pit or bathing unit structures** which constitute:

- A high source of contamination jeopardizing the public health situation
- A physical risk of injuries for the camp population and child in particular

- ✚ Latrine structure stability has to be ensured and in case of risk on one structure to be decommissioned or repaired
- ✚ The slab use for the latrine construction are equipped with a feet removable cap, and then awareness should take into account the closing of this cap

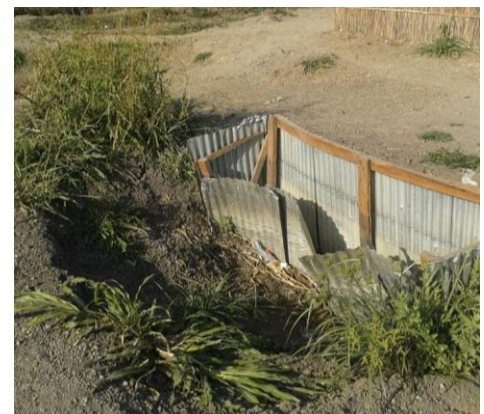
The fact is that the quality of the latrine facilities achievement is pretty low in Bentiu. The completion is not up to the standard (backfill of the pit,

doors missing, cap open, plastic sheeting ripped,...) until a certain level the work completion can have been **compromised by the recent flood**

3 months ago and especially by the **numerous looting** of the facilities materials by the POC populations. However, the quality level of the work was expected to be higher. **3 months after** the last emergency (flood), **it is time for the partners to work on a drastic improvement on regard to this aspect.**

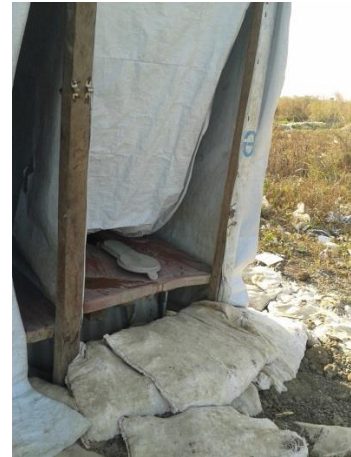
The latrines does not have vents pipe but the partners plan to include the vents pipe in the design of the new latrine.

UNICEF is trying to address this issue by getting people organize to share and care about one facilities with smaller latrine block, and they plan in the future to work on HH latrine build with real contribution from beneficiaries.

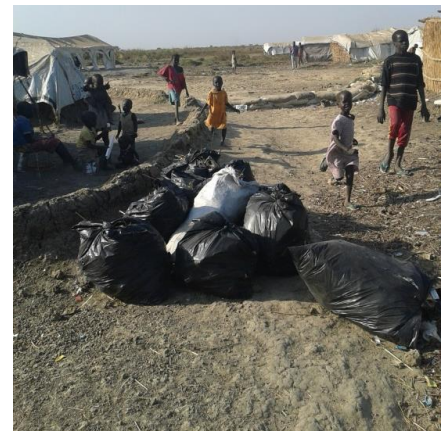
The solid waste disposal is organized using plastic bags at HH level. The plastic bags are carrying from HH location to one central spot by the community workers getting incentive payment and then the community workers load a collection truck and offloaded at disposal site. The system have to be clearly improve in terms of efficiency as still in many spot within the POC's solid waste spread around are noticeable and in terms of community contribution. The collection of garbage up to the central spots should be made by HH without any incentive payment. **At the disposal site, the management has to be improved with clear guideline apply consistently** (stabilization of the waste by incineration and burying in safe place).

- ✚ The solid waste management has to be improved, appropriate containers (to avoid plastic bags left along the road, damage and spreading of the waste in the environment...) should be implemented to dispose garbage plastic bag by the community before transport and disposal in the dump site.
- ✚ Until the garbage truck the collection should be ensured by the population as free contribution.
- ✚ The dump site should enable safe and systematic incineration of the garbage to enable its stabilization and avoid nuisance, thus solid waste should be buried

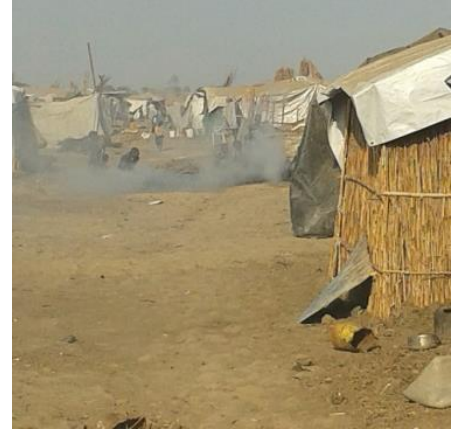
The last point will be the necessity to ensure safety and ***mitigation of various risk identify within the POC's*** such as:

- the risk of fire due to wild fire made within the dense part of habitat constitutes of reed or grass shelters and presence of wind
- the risk of injuries due to fall in non-protected excavation
- etc...

- A risk assessment of the various risks present within the camp should be conducted and contingency measures hold for instance to address fire risks as notice in the camp (people burning some waste in a middle of the gateway between the shelters in grass or reed and with strong wind...)/ of course the flood problem have been consistently take into account by IOM and others partners
