RAPPORT DE MISSION

Subject: South Sudan WASH RSO Mission (*refugee's part of the mission*)
Auteur: Jerome BURLLOT (WASH Adviser/RSO Nairobi)
Date: Du 31th August au 4th September 2015

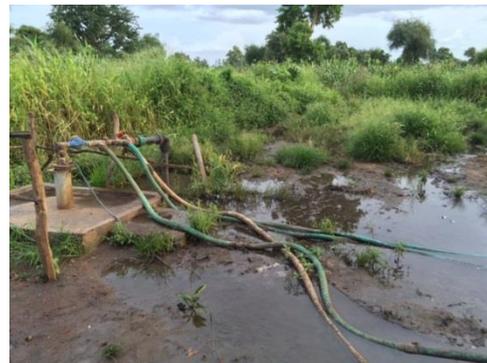
- ⇒ BH kept open (the cap not fix on the top) then anybody could drop anything in the BH and pollute the water resources.
- ⇒ Pipeline around pump station lay down in a pool of mud with a lot of leaks (meaning risk of contamination of the pipeline when the supplied is stopped by occurrence of negative pressure gradient- depression which will implies intrusion of dirty water)
- ⇒ Electric cable lay down in water pool in case of default of insulation all the electric installation could burn including the motor of the pump (*see pic in front*).
- ⇒ Too many different type of equipment used (generator, pump...) which undermined the efficiency of spare part supplies

network. There is no drainage pipe to dispose this water. They must implement a system (using a tee, valve and piece of pipe) to dispose the waste water in appropriate way. This practice is public health breach.

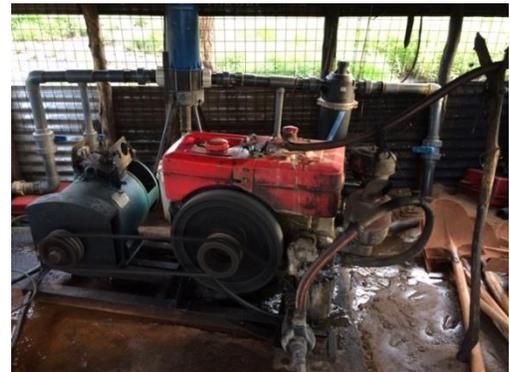
ACTED encountered almost **daily breakdown** with **generator** because of **16 Chineses** (2011-2012, so not that old; see pic in front) very poor quality generators purchased by **IOM** and implemented at almost each BH location

The UNHCR mentioned that this BH can have much stronger yield and a bigger pump should be installed. That could have been a reason to oversize the energy supply equipment, but still if you want to oversize your system you should be able to

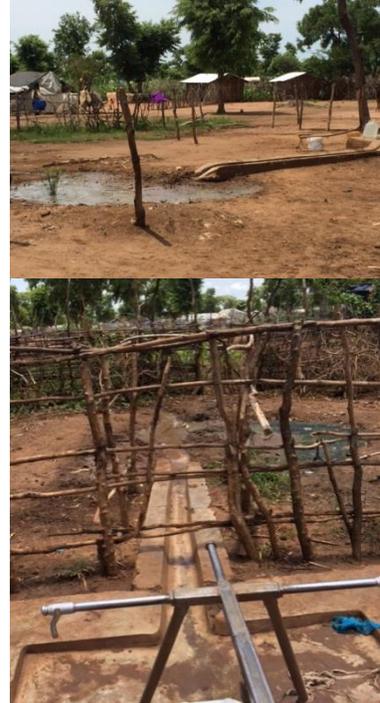
Drainage: a lot pool of mud can be noticed around the camp. The problem is the nature of the soil (large portion of black cotton soil) which has very little seeping capacity and then water is standing in surface (*see up pic in front*). The main spot should be addressed by upgrading of the ground with maram (13m³=700SSP, so cheap for the area) or drainage channel until lower disposal point. The problematic remains tricky to be addressed properly, but it does not mean that nothing can be done. ACTED propose in all the camp where they work in Maban to direct waste water from the water point to a fenced perimeter used to growth for instance banana trees which absorb a lot for water (*see low pic in front*). At some point those small gardens located at each water point could use by pump operator as contribution to his incentive... This idea is very relevant...

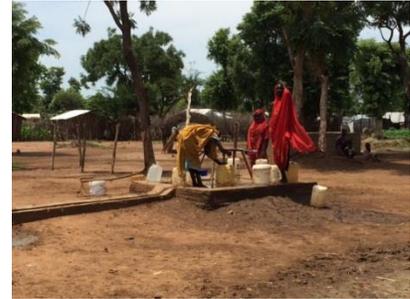
In Kaya camp, the 23 000 refugees get about 22L/day/pp, distribute through 320 taps spread over 66 water point supplied by 460m³ of storing capacity and 5 BH, plus pump station. The supply in gravity struggles because of the flat configuration of the site. The ***design and implementation of the water supply system*** including the ***solar direct pumping*** system have been achieved by ***OGB***.

11 T70m³ tanks are planned to be installed within the camp and 4 storage tanks of 70m³ as well at main pumping station location. ACTED to implement one tank/week (***TO FOLLOW UP***).

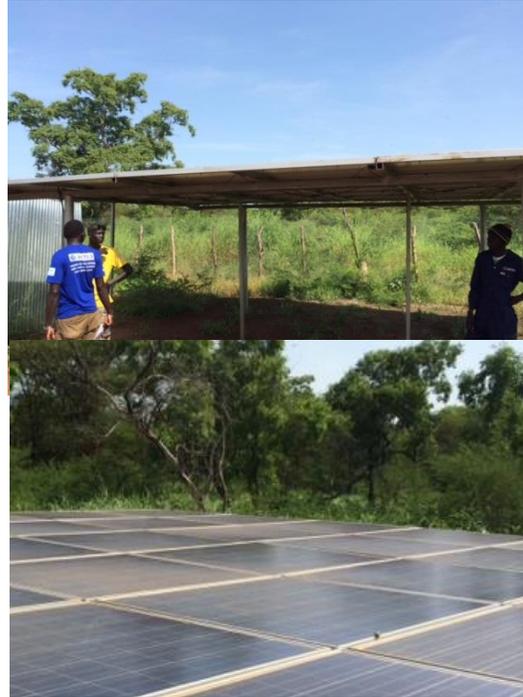
panels for this pump are also very **improperly installed on a flat frame** (see pic in front) **without any tilt, and are very dirty** (see pic in front).

No cleaning procedure has been set up so far and no cleaning tools available. Another solar asset has very light tilt much under what should be required.

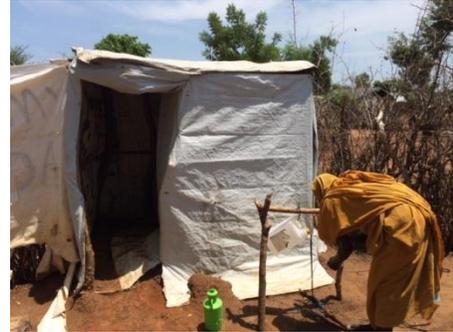
For the sanitation, the situation is more or less the same as for Doro/Gendressa camp, main difference are:

- ✓ In Kaya, ACTED provide the first round of tools and product to clean the latrine
- ✓ In Gendressa, the users do the decommissioning of the latrine pit
- ✓ Lifespan of the latrine pit is estimate as 1 to 1,5 years. When in Doro they mentioned from 4 months to 1 year which demonstrate a not normal difference in number of user per stance.

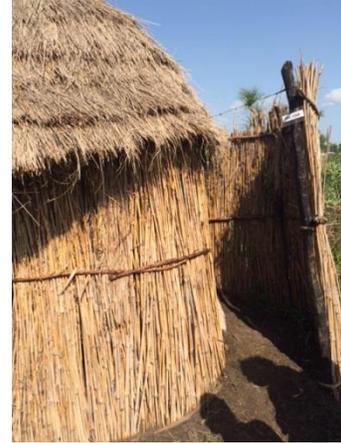
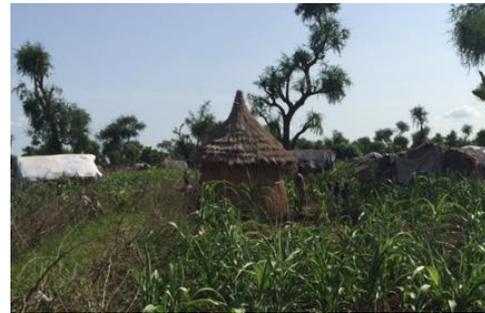
- ✓ The latrine shelter is made of local materials such as grass people use for fencing or even house construction.
- ✓ The latrine pit is between 3 to 4 m according the type of ground. The lifespan has been estimated at 1,5 to years when ground is clay (because of the seeping capacity of the ground/pit) and 3 years when the ground is sand.

- ✓ The magic plastic slab with foot handling cover are mainly used (about 85 to 100USD/slab)

MEDAIR shift from use of plastic sheeting for the latrine shelter to local materials (see pic in front) at the beginning of the year, which is highly appreciable (more replicable/sustainable and more cost effective).

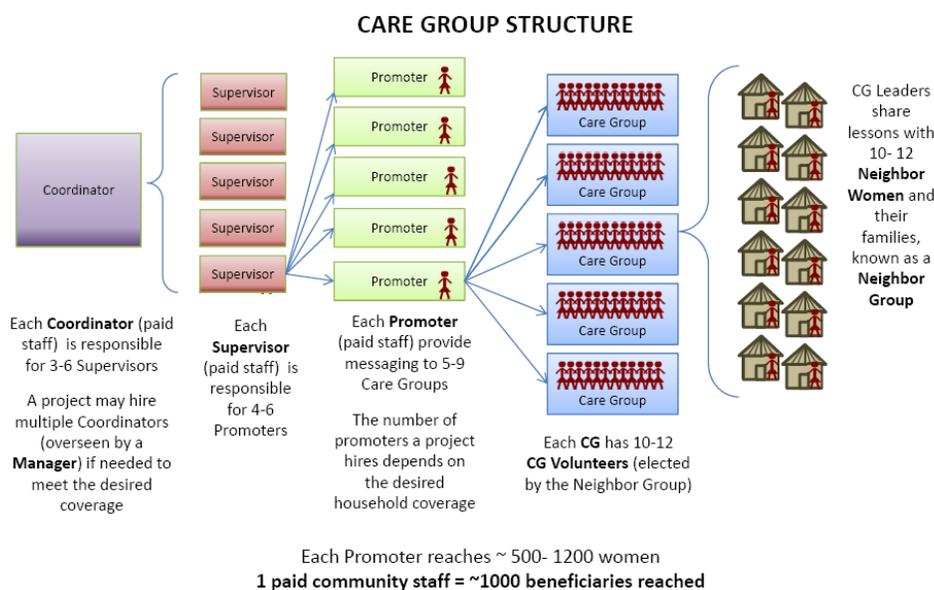
MEDAIR is trying to be dynamic, creative and innovative in hygiene promotion which is highly appreciated. The structure of the CARE group² model is as follow:

The method is based on mentoring or coaching principles and using tools from adult education (*SARRAR method*). The neighbor group (*about 12HH*) will elect on woman leader to attend the CARE group. 1 supervisor will trained 1 hygiene promoter who will be in charge of facilitating the CARE group and trained a group of 12 leader women and coach them in their activities with their neighbor group. The hygiene promoter will assist regularly to the activities implemented by the leader woman and will give a feedback at the next session of the CARE group to adjust and reinforce the initial training.

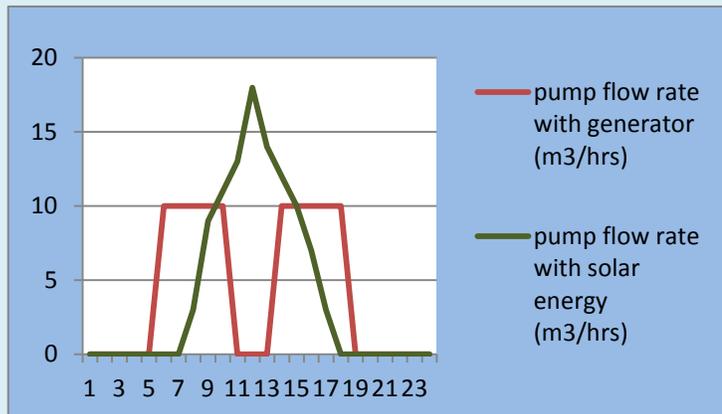
Flow rate evolving along a day to get the same daily production according source of energy used

<p>Note: The table here below show what would be typical difference between selecting a pump working with solar energy and selection a pump working with generator to get the same daily water production. As you can see the pump working with is not pumping at the same flow rate full day, it pump much more at noon as the direct sunlight is higher than at 3pm or 10am for instance. The pump working with generator is pumping at a fix rate all day long. In consequence, the pump to be selected to get the same daily quantity of water</p>

should pump much more quantity of water during few times around noon and the BH yield should be able to match this flow rate during enough time. Then the BH yield has to be much higher than the BH yield for a pump working with generator. The pump working with solar should be 18m³/hrs at max for short time when the one working with generator will be 10m³/hrs, same for the yield of the BH.
