## EUROPEAN COMMISSION

### RAPPORT DE MISSION

**Subject:** UGANDA WASH RO Mission (Adjumani sites)  
**Auteur:** Jerome BURLLOT (WASH Adviser/RO Nairobi)  
**Date:** 13<sup>th</sup> – 16<sup>th</sup> of March. 2016

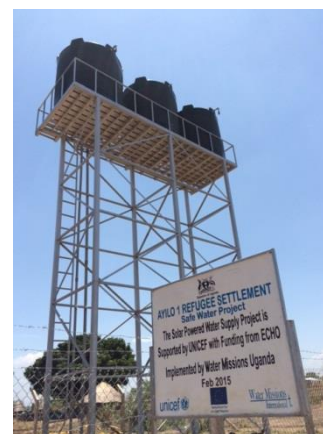
The storage tanks (3\*10m<sup>3</sup>) are regularly cleaned with appropriate procedure. As the ground water is pretty load with iron, WM monitor the deposit in the tank to plan cleaning in accordance.

WM have done appropriate hydraulic calculation to design the water network and storage facilities (elevated at 10m high, see picture aside). WM is performing chlorination but it is based on a fix dosing rate of chlorine injection when pumping with solar energy, the water flow (and then the needs of chlorine injection) will varies along the day and along the year. The good point is that the chlorination system is a static system which does not need energy supply.

There is still need to improve the groundwater monitoring. There is also strong need to monitor the daily and yearly performance of the solar system to better analyze the gain in performance ensure by the oversize of the solar generator. This level of analysis should contribute to a better economic analysis and then a better selection of design parameter and notably correction factor.

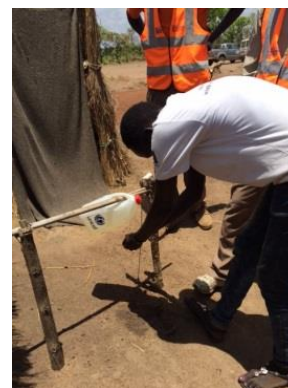
The model home approach (*see picture in front*) is based on motivate and successful householder who want to get some support to better organized their habitat hygienic wise and translate hygiene messages into practical actions and improvement. Only one model home (*see picture aside*) has been visited (for sure the best one!) but at least this one was quite good in terms of hygienic practices, equipment and organization (latrine with cap on the drop hole, tippy tap for hand washing supplied, elevated dishes rack, clean environment...).

In the meantime, as it is an innovative approach in the context it should be rigorously monitored and documented to ensure good lesson learnt production and appropriate guidelines for potential replication or/and improvement, which does not seem to be the case (*no documentation have been provided despite of request*).

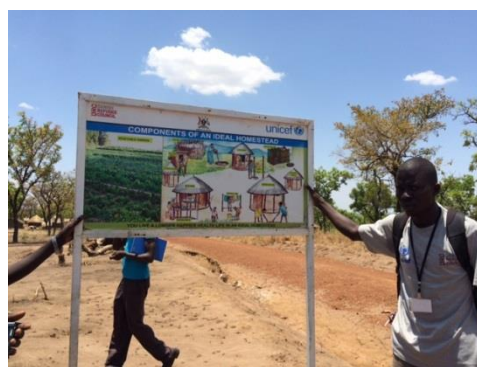
One of the good points was the presence at most of the water point of sign board with awareness messages (*see picture aside*). We can note that we missed the ECHO logo.
