## Using drones to inspect post-earthquake road damage in Ecuador

### Background

## Implementation

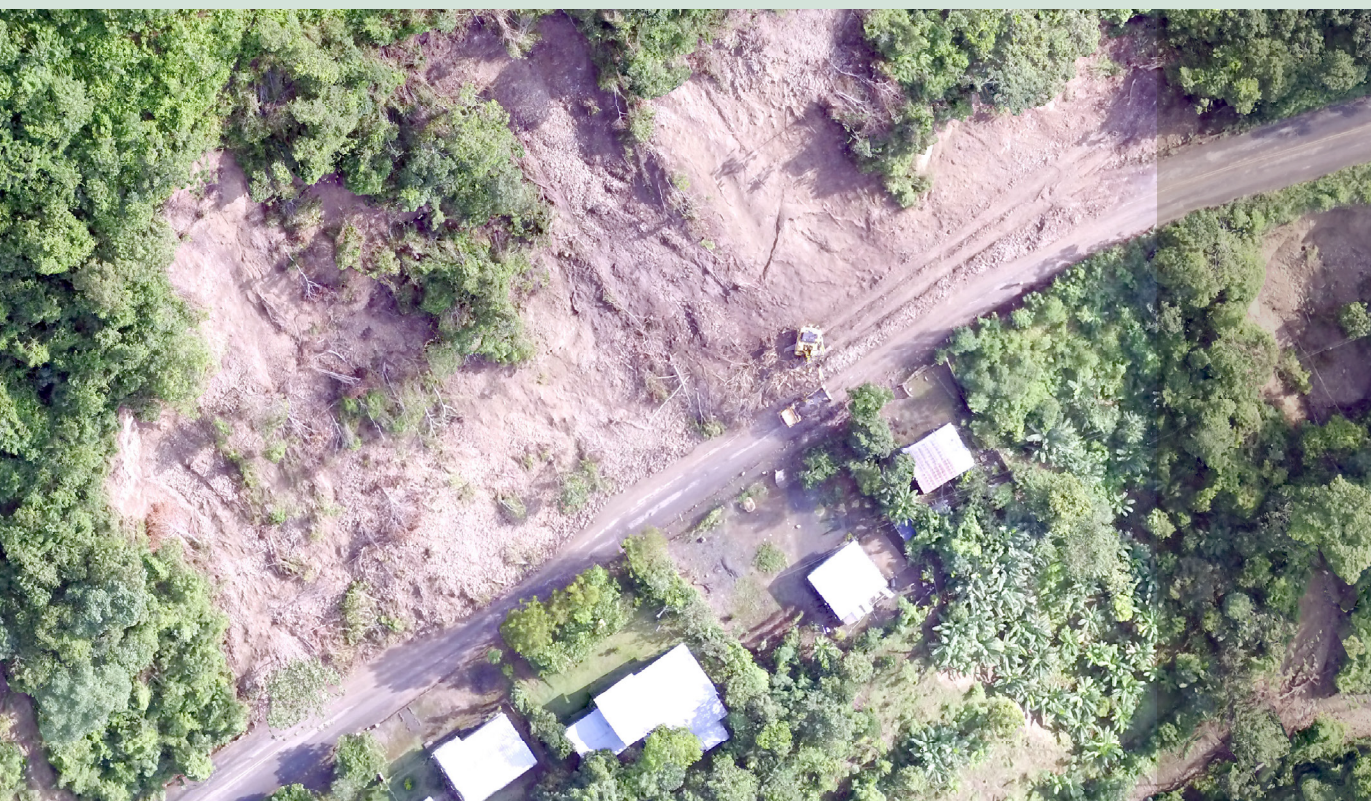
**Figure 1** A landslide in St Isidro, Manabí province caused damage to roadways following the earthquake.  
Image: Francisco Ruiz, April 2016.

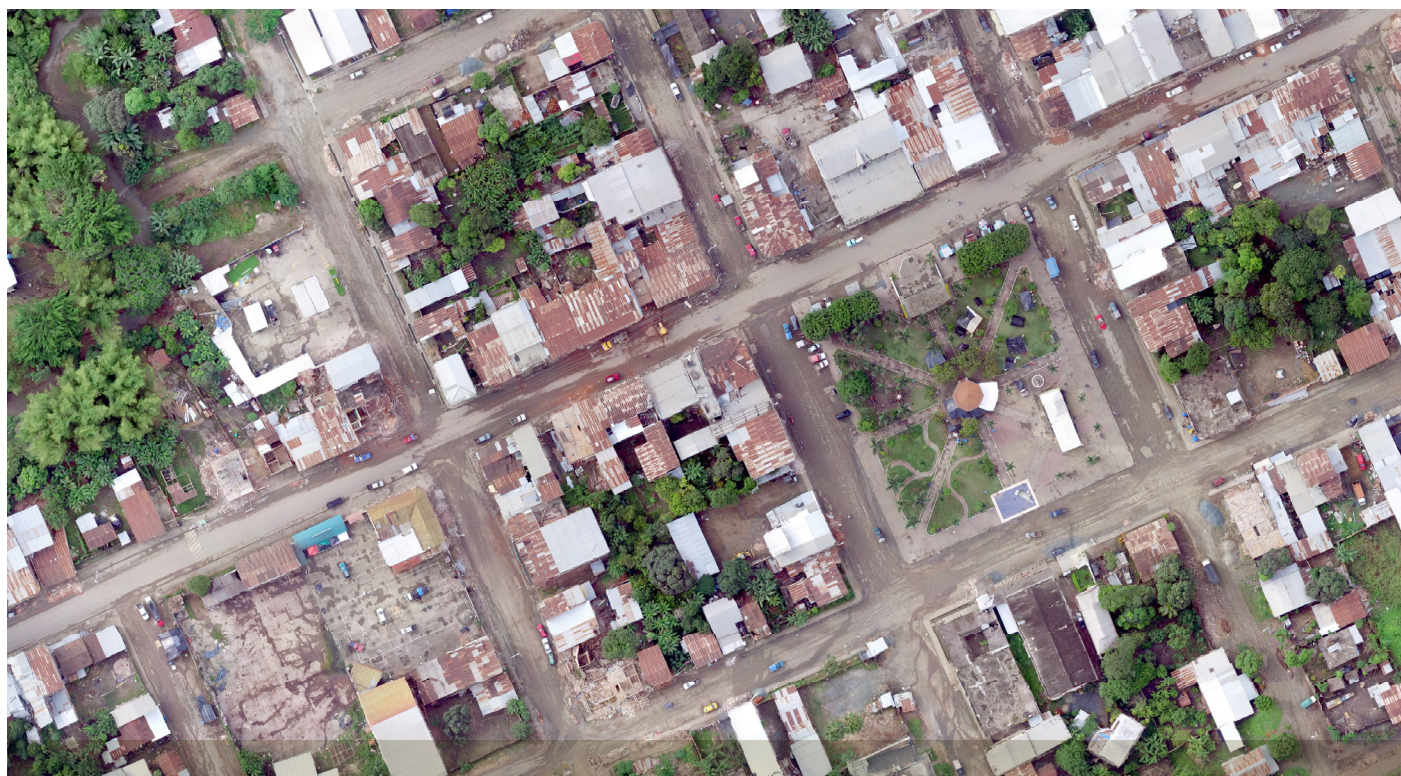
**Figure 2** An aerial image of St Isidro showing damage caused by the earthquake. This was captured by an Inspire 1 drone. Francisco Ruiz, April 2016.

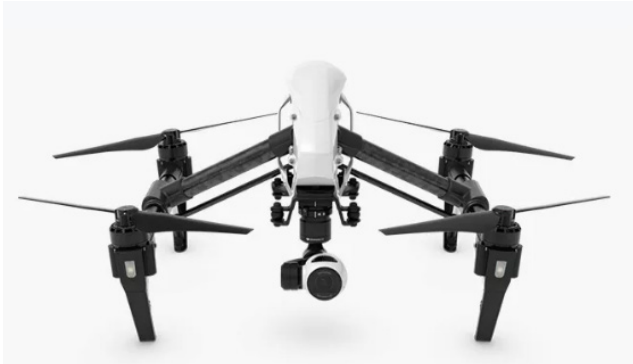
**Figure 3a** The Inspire 1, made by Dji

DJI Phantom 3 Professional and DJI Inspire 1 – and several fixed-wing eBees. The Phantom 3 can fly for 23 minutes and up to 5 km away from its pilot. It can livestream and take videos and still images. The Inspire can fly for 15 minutes and up to 5 km from its pilot and is also able to provide imagery in real time. Both the Inspire 1 and Phantom 3 Professional take images with a resolution ranging from 6 to 10 cm ground sampling distance (GSD). The eBee is a fixed-wing craft and able to cover 12 km<sup>2</sup> in one flight, with a flying time of about 50 minutes. The eBee possesses an 18.2 megapixel resolution camera with a 1.5 centimetre GSD, and is a widely used mapping drone. Typically, a team of two to three people conducted a mission together, with one pilot and at least one observer.

The Inspire 1 was a favourite of drone pilots, according to Ruiz, because it can be flown manually and “obeys” the pilot well. However, a fixed-wing drone like the eBee has the added value that it can cover more ground. The take-offs and landings of the eBee made them a little more challenging to pilot, mainly because some of the surface areas, such as rubble or thick underbrush, were not ideal for landing this type of drone. The operating environment in many areas consisted of dense forests, which made it difficult at times to observe the drone’s pathway. This is also why it was so important to pilot them in teams.

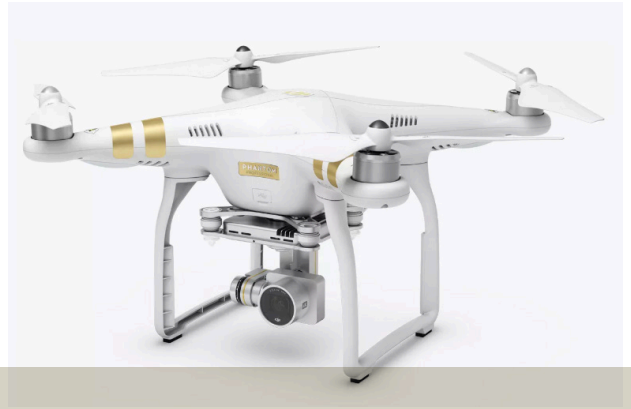
**Figure 3b** The Phantom 3 pro, made by Dji

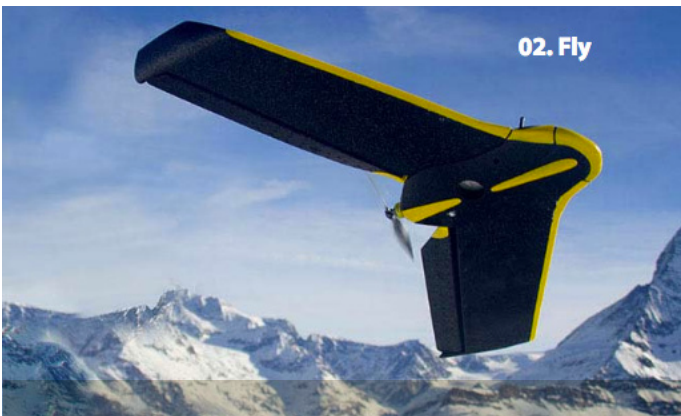
**Figure 3c** The eBee, made by Sensefly

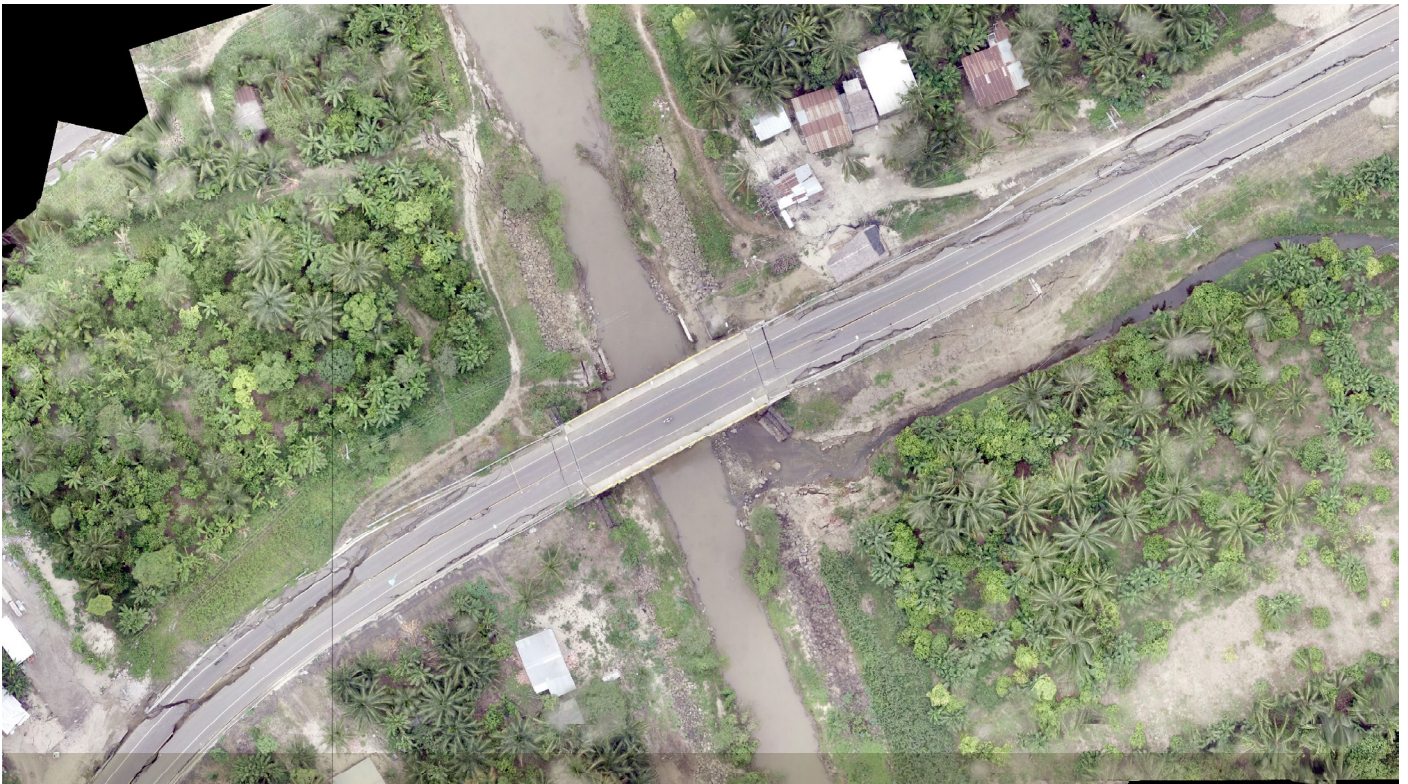
**Figure 5** Aerial imaging of a damaged bridge taken by a Phantom 3 pro on a flight conducted together with the Ecuador Ministry of Transport. Francisco Ruiz, April 2016.
