## **MISSION REPORT**

**Subject: Monitoring mission – SRI LANKA**

**Author: Luc Soenen - TA WASH - Shelter**

**Date: 28 – 29 September 2016**

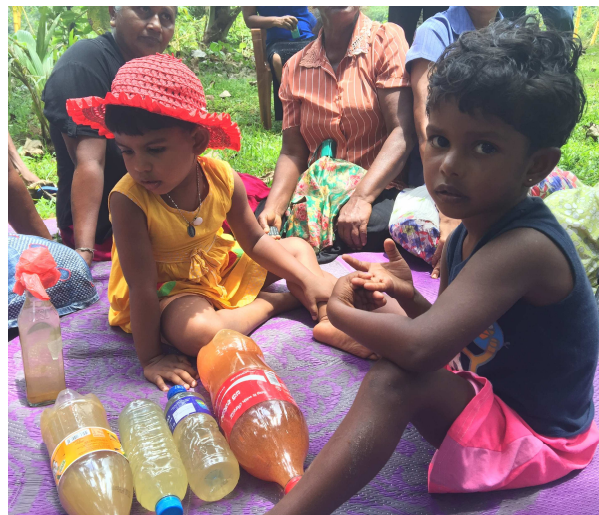
In spite of correct and thorough cleaning, (dewatering, wall cleaning, chlorination) x 2 up to a number of times like 10, water from wells remains highly turbid; that is a reality for some 1000 families. People heat water and filter with clothes. People, and especially children, have suffered of stomach problems like diarrhea.

Samples of highly turbid water from a few wells

When asked about needs, people mentioned electricity, which is missing during flood, it is needed for displacement centers + canoes for rescue. Regarding water turbidity, people cite central treatment – SLRC carries out such projects, using a good well to pump water into an elevated reservoir distributing by gravity. That may be good long term solutions or connect to neighbor nearby networks. Unfortunately, **proper water analysis** was not done – on our request, it will be done soon; it can help to advocate and support requests. Although tough, the immediate recommendation is to **clean wells again** and the situation should improve with time, as it did elsewhere.

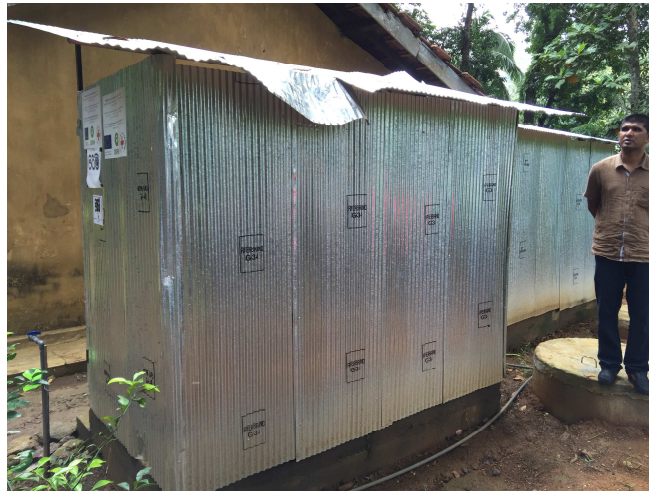
Latrines are connected to simple, non-sealed bottom pits, whose capacity is about 2.4m<sup>3</sup>.

Some pits were observed to fill up while other ones were empty because the latrines closer to the inhabited area are more used.

Corrugated galvanized iron sheets (CGIS) are used for most constructions, kitchens, bathing areas, latrines. Unfortunately, the sheets used were observed gauge 34 (G34), very thin, fragile, very low quality, they will necessarily not last long, up to 3 months maybe. It is now known camps will last for more than a year. Then, better **quality CGIS**, at least gauge 32 or, better, less, **have to be used**, and partners promised that will be the case. In case G34 CGIS were already purchased and are already in stock, try to exchange them; if that is not possible, double them.

2 latrine blocks with soak pits and a hand washing point

Necessary improvement / correction: **have all pits connected as possible**, at the possible greatest depth, so that pits balance and fill up the same way, hopefully without getting full. That will be possible and implemented for all new latrines; for the existing ones, connections will be added, as deep as feasible.
